**E1552.04-113-11-R0**  
**ACOUSTICAL PERFORMANCE TEST REPORT**  
**ASTM E 90 AND ASTM E 492**

**Series/Model: 5 mm Regupol Sonus Rubber Underlayment**

**Specimen Type: Floor/Ceiling Assembly**

**STC     53**  
**IIC     52**

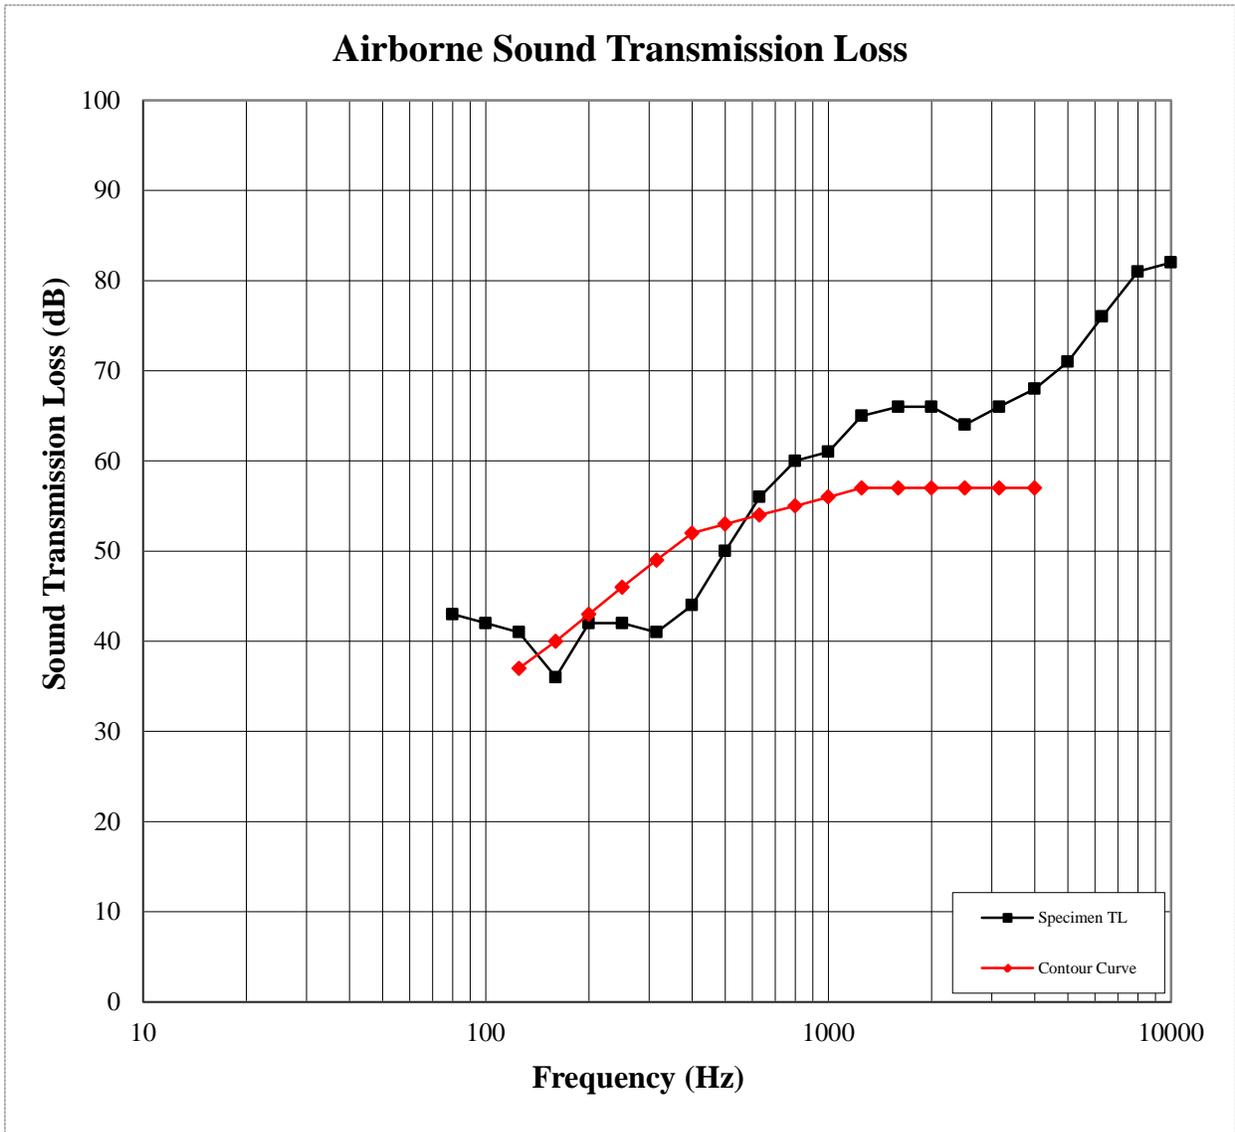
### AIRBORNE SOUND TRANSMISSION LOSS ASTM E 90

**STC Rating**      **53**      (*Sound Transmission Class*)  
**Deficiencies**      **28**      (*Sum of Deficiencies*)

<b>Test Date</b>	10/28/14
<b>Data File No.</b>	E1552.04
<b>Client</b>	Regupol America
<b>Description</b>	7 mm Ceramic Tile, 5 mm Regupol Sonus Rubber Underlayment, 203 mm Concrete slab
<b>Specimen Area</b>	10.98 m <sup>2</sup>
<b>Technician</b>	Leeland S. Hoover

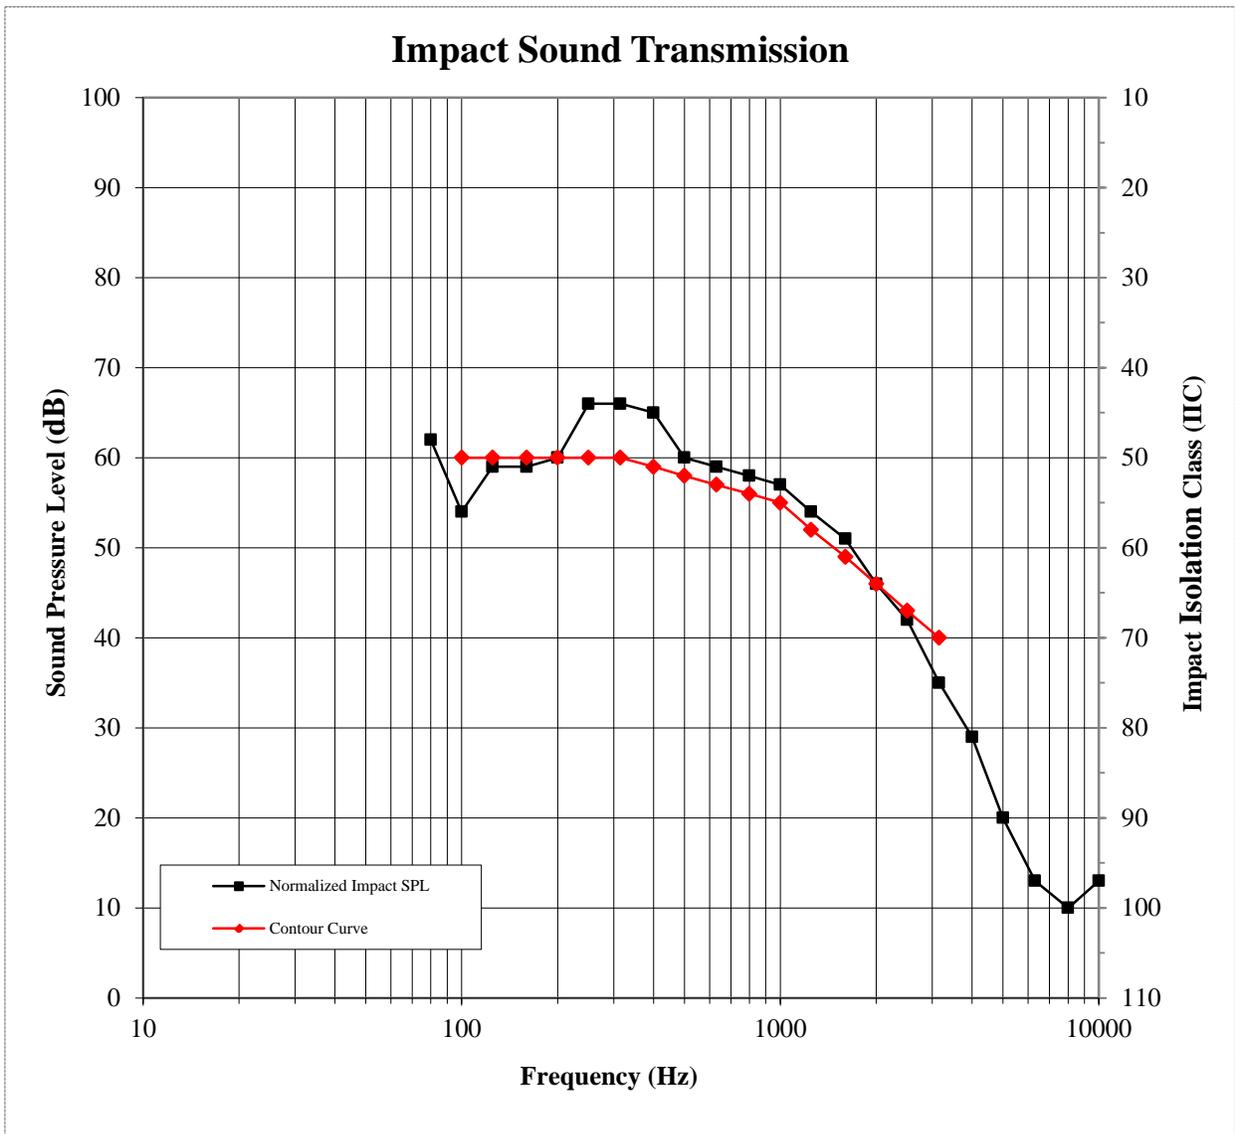
**IMPACT SOUND TRANSMISSION**  
ASTM E 492

**IIC Rating**      **52**      *(Impact Insulation Class)*  
**Deficiencies**    **30**      *(Sum of Deficiencies)*

<b>Test Date</b>	10/28/14
<b>Data File No.</b>	E1552.04
<b>Client</b>	Regupol America
<b>Description</b>	7 mm Ceramic Tile, 5 mm Regupol Sonus Rubber Underlayment, 203 mm Concrete slab
<b>Specimen Area</b>	10.98 m <sup>2</sup>
<b>Technician</b>	Leeland S. Hoover

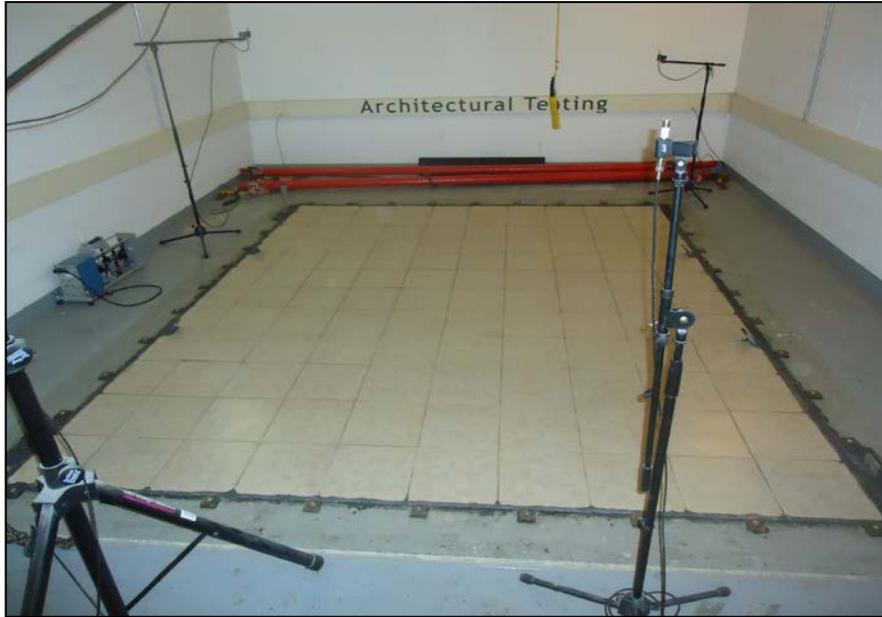
**Source Room View of Test Specimen Installation**

The total weight of the floor/ceiling assembly was 5553.9 kg. Architectural Testing will store samples of the test specimen for four years. Photographs of the test specimen are included in the attachments. A drawing of the test specimen is included in the attachments.

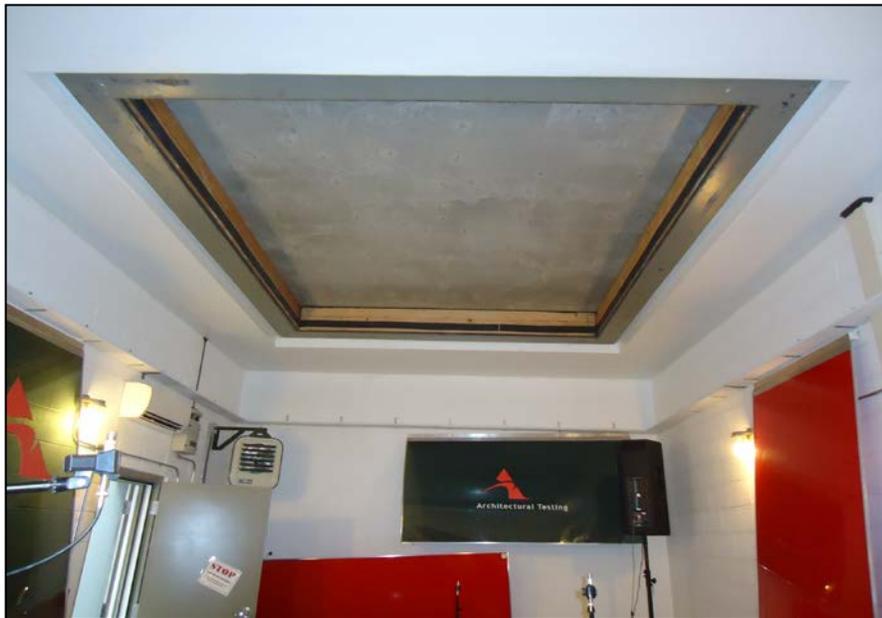
**Receive Room View of Test Specimen Installation**
